Maryland Historical Trust State Historic Sites Inventory Form

Survey No. F-4-114

historic Pettingall/Bussard Farm

street & number 8836 Hollow Road ___ not for publication

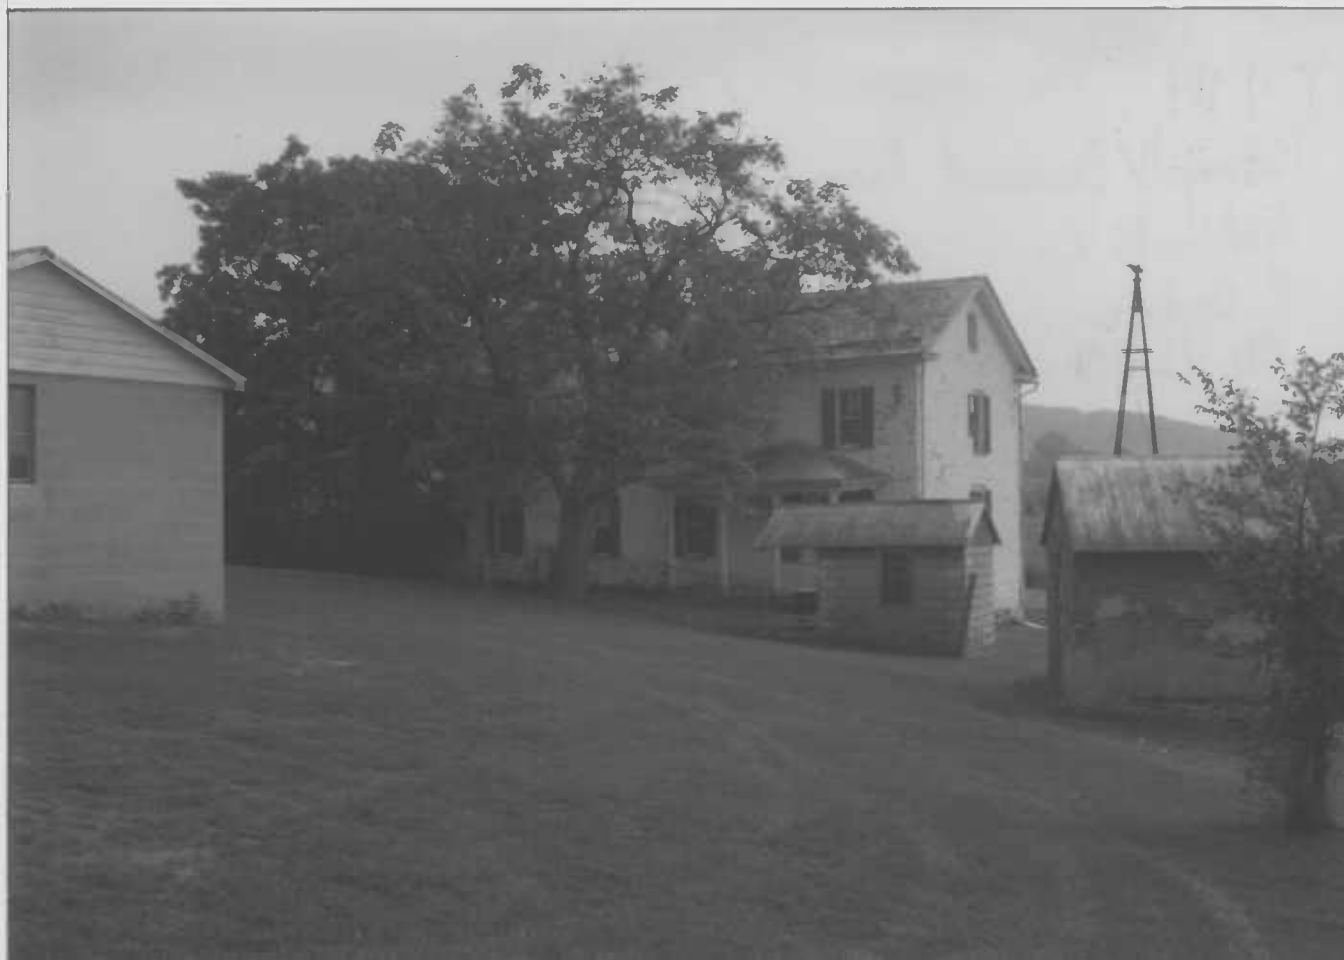
5 of 16

Principal Dwelling, view northwest, detail front porch & window

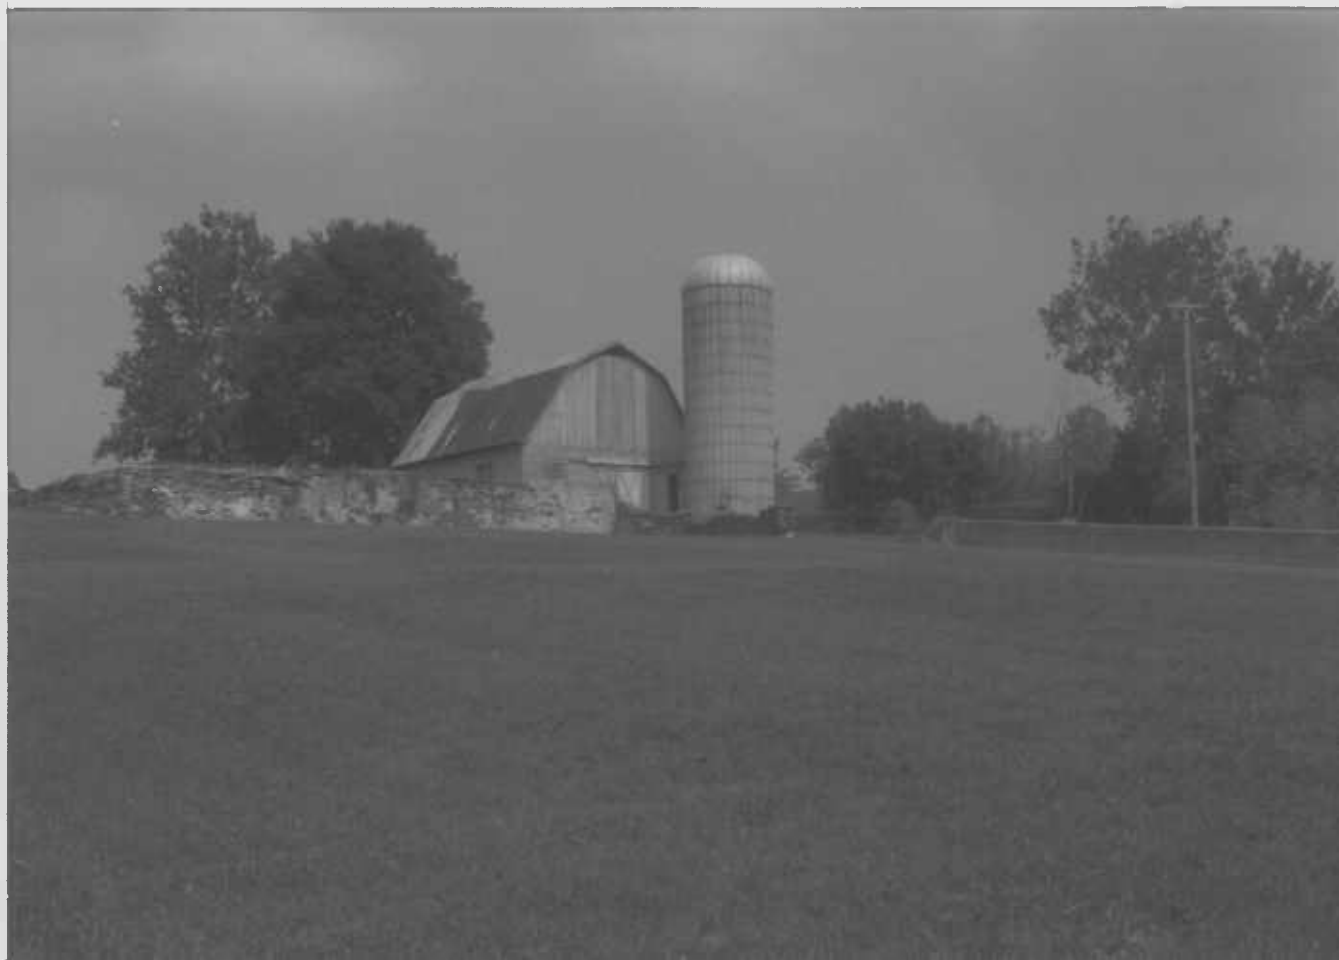
14 of 16

Foundation Ruins of Bank Barn, Dairy Barn, & silo, view northeast

The foundation ruins of a bank barn (ca. 1860) are located northeast of the principal dwelling. The bank barn was destroyed by fire in 1957. The primary (north) elevation is defined

by an earthen ramp supported by a stone foundation wall on the ground level. The remaining foundation walls of the former bank barn have been removed. The foundation ruins of a bank barn predate the extant principal dwelling.

The dairy barn is located in the northeast portion of the building complex. The barn is a rectangular plan, two-and-one-half story, three-bay building constructed ca. 1930. The barn, constructed of rusticated concrete block, rests on a poured concrete slab. The front and rear elevations on the first floor level feature a central wood sliding track door constructed of vertical wood boards, flanked by 12-light, wood-frame hopper windows. The side elevations feature two 12-light, wood-frame hopper windows. The barn terminates in a gambrel roof clad with corrugated metal. The hayloft is accessed from either gable end by sliding track doors located on the second floor level. The hayloft openings are sheltered by a gable roof extension which originally housed a block and tackle.

A circular precast concrete silo (ca. 1930) is located southeast of the barn. The circular plan silo is approximately 15 feet in diameter and 30 feet tall. The silo terminates in a standing seam metal dome roof. The silo was constructed using precast concrete sections joined by exterior, metal turn buckles. A metal ladder is attached to the side of the silo. The ladder provides access to metal doors which are located at eight-foot intervals for the height of the structure. The silo is attached to the southeast corner of the dairy barn by a small concrete block hyphen terminating in a gable roof sheathed with corrugated metal.

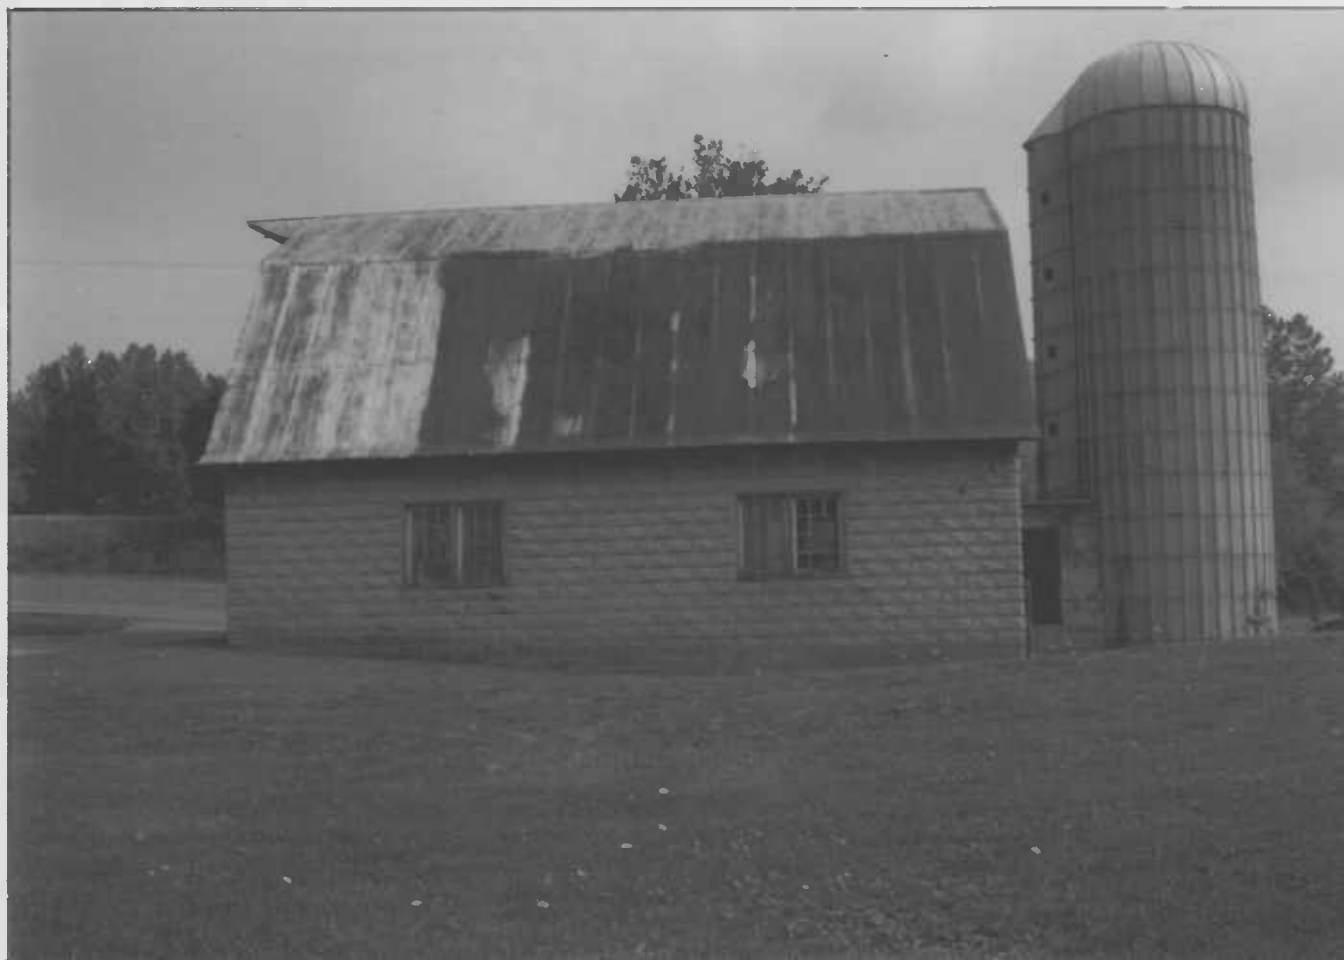
16. g. Dairy Barn and Silo, view east

The interior of the dairy barn is divided by an aisle that extends down the central axis of the barn. Metal milking stalls are situated on either side of the aisle extending the length of the building. A feeding passage extends between the eave wall and the milking stalls. Mechanical milking units were not present during the survey. The structure is in fair condition; it currently is used for storage.
